## GCS Home Inspections and Thermal Imaging

# Infrared Thermal Survey

## *Heat Loss Survey*

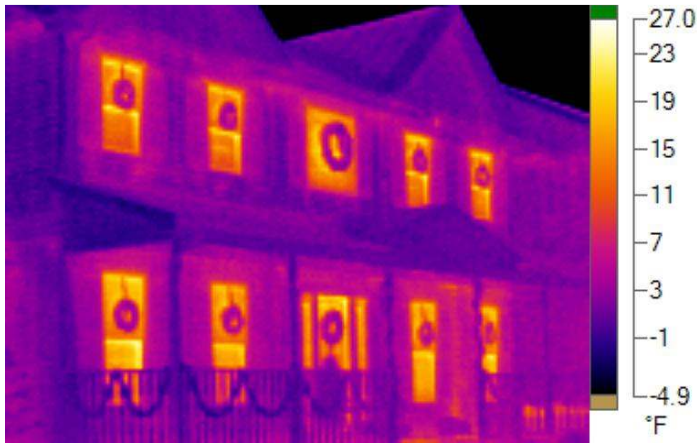
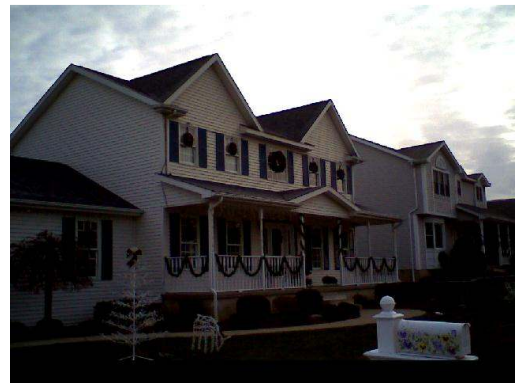
**IR001025.IS2**  
12/18/2009 8:49:37 AM  
Windows – typical heat loss areas

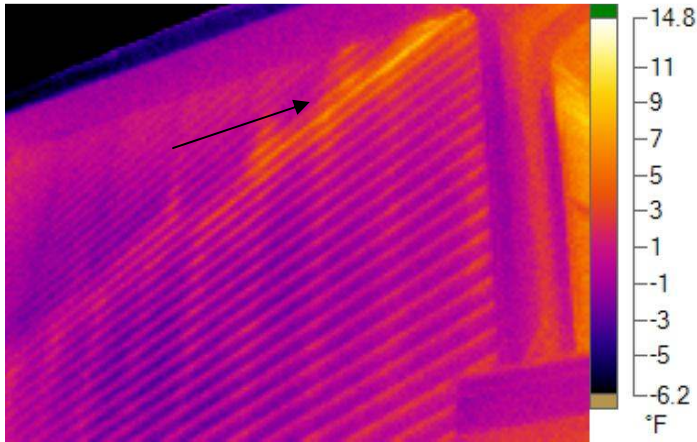
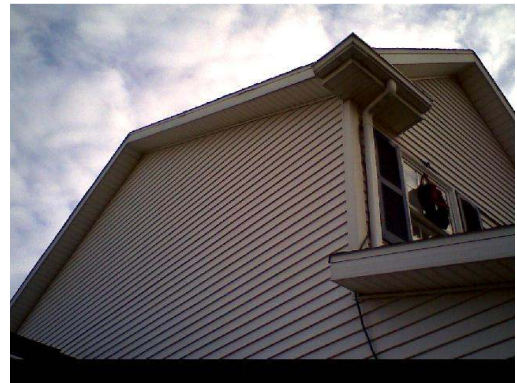
**IR001027.IS2**

12/18/2009 8:51:25 AM  
Heat loss behind siding

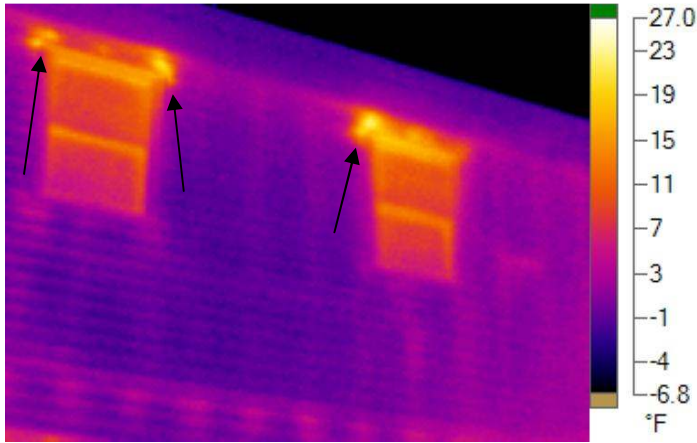
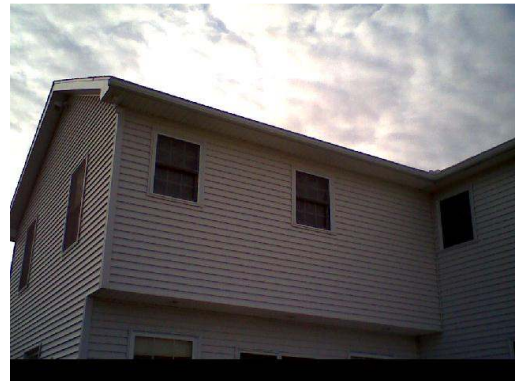
**IR001028.IS2**

12/18/2009 8:52:05 AM  
Heat loss at window corners

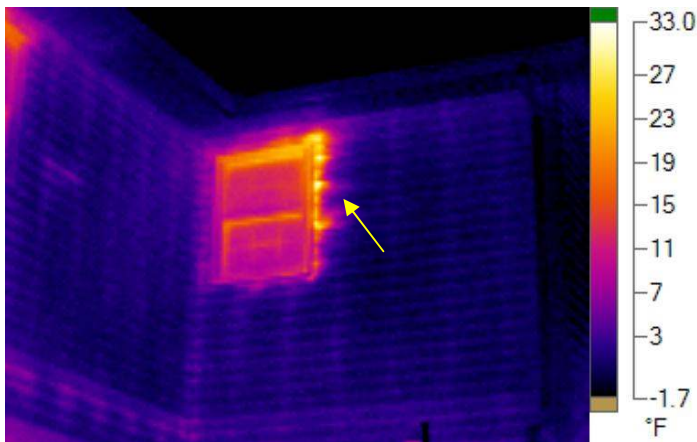
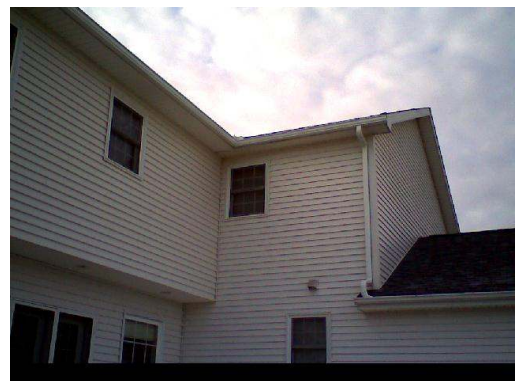
**IR001029.IS2**

12/18/2009 8:52:18 AM  
Heat loss at window edge

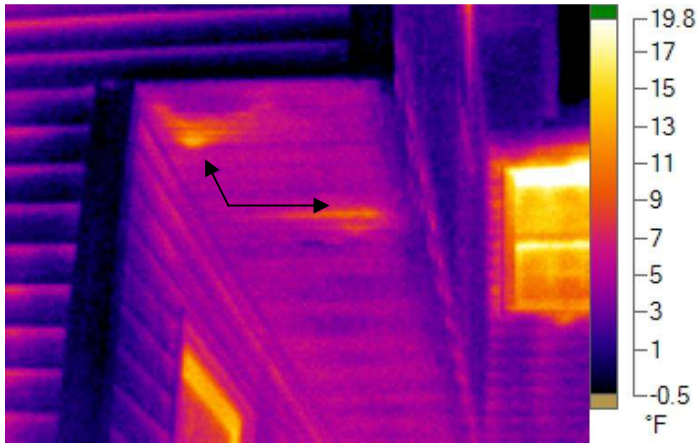
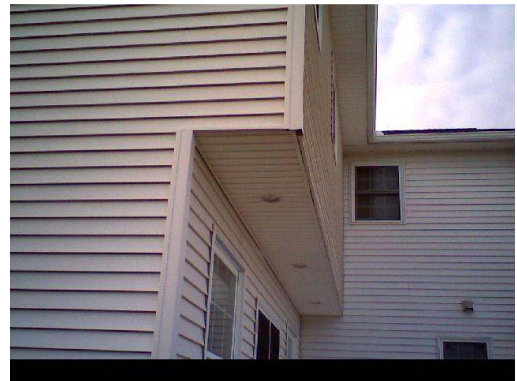
**IR001030.IS2**  
12/18/2009 8:52:32 AM  
Heat loss

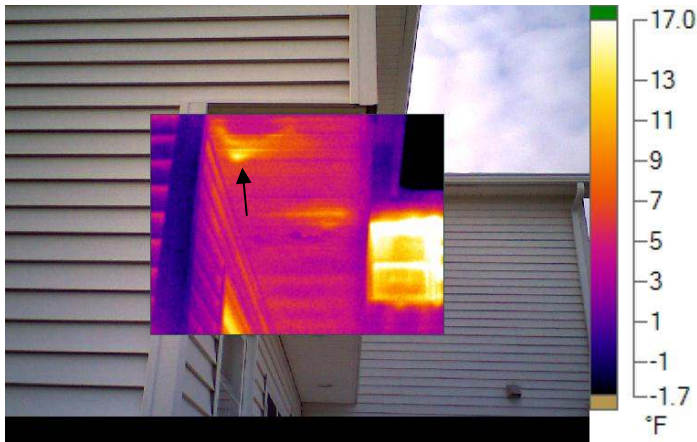
**IR001031.IS2**  
12/18/2009 8:52:48 AM  
Heat loss

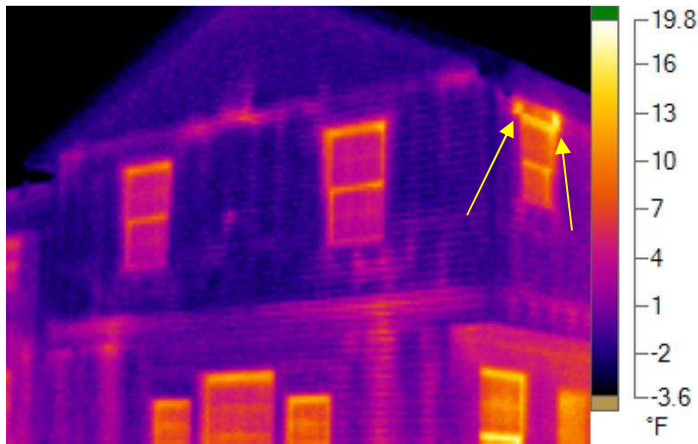
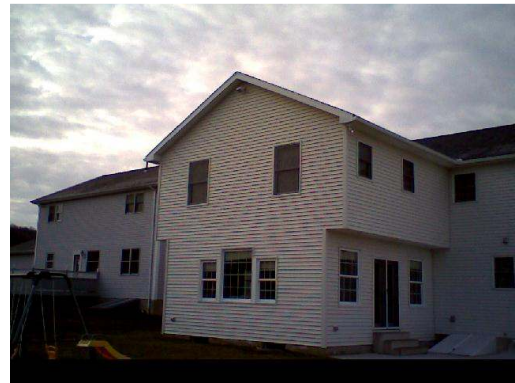
**IR001032.IS2**

Heat loss at window corners

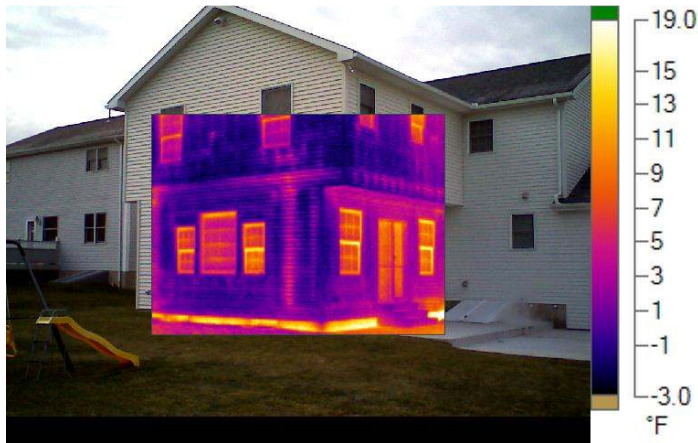
**IR001033.IS2**

- Air infiltration was observed at exterior entrance doors, some windows, along baseboards, and one or more electrical receptacle cover plates.
- The basement area was inspected for significant contributing factors of heat loss. Minimal findings were observed. Unfinished, above grade basement walls are missing insulation although insulation is installed at rim joist areas.

Heat loss at basement exterior wall

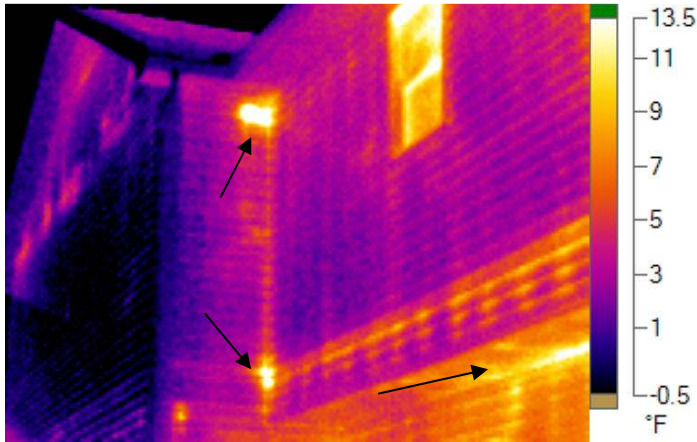
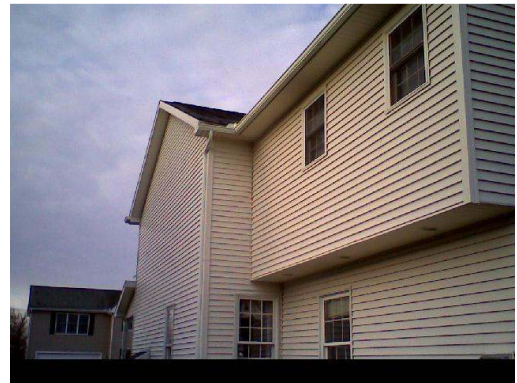
**IR001035.IS2**

- New construction is cantilevered at the east and west edges, exposing more surface area to the exterior elements; heat loss observed at isolated soffit areas but not associated around recessed lighting.

Heat loss at corner and under soffit

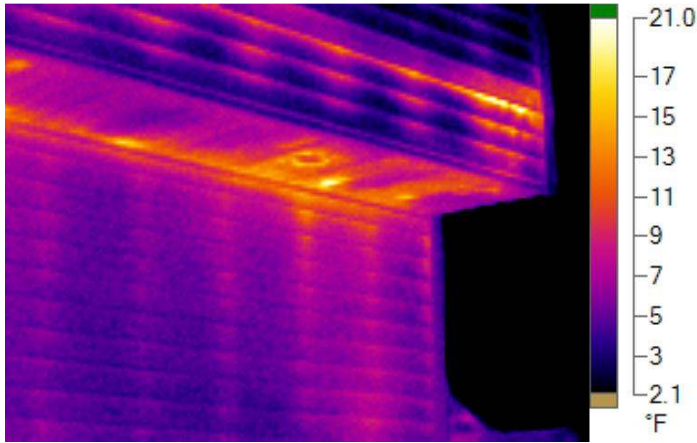
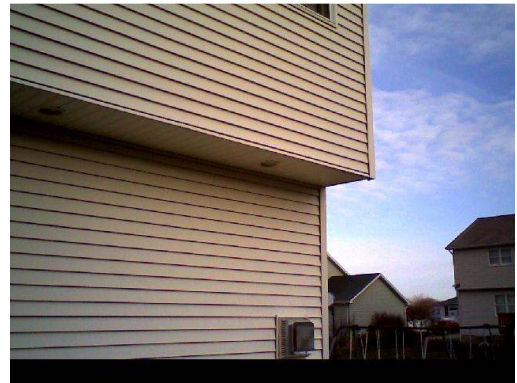
**IR001036.IS2**

Heat loss under soffit and at siding

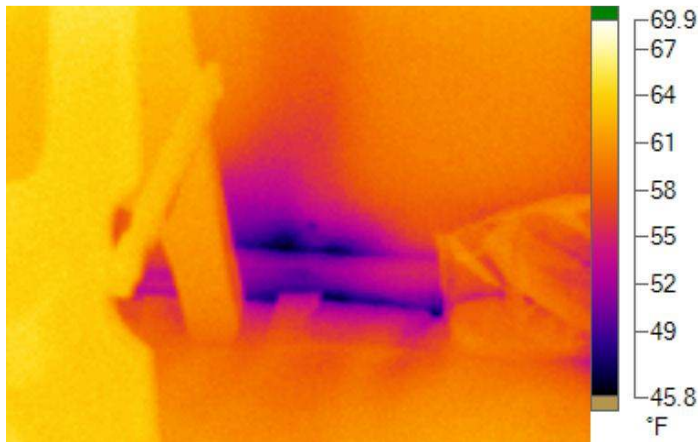
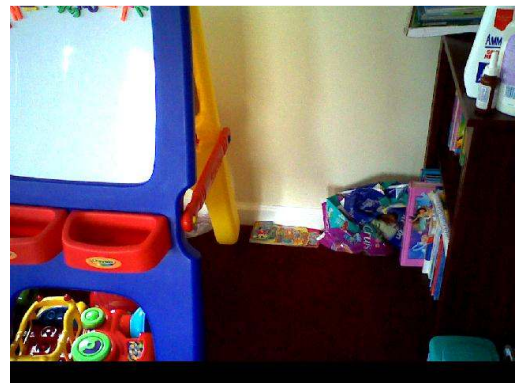
**IR001037.IS2**  
12/18/2009 9:07:57 AM  
Air infiltration at wall

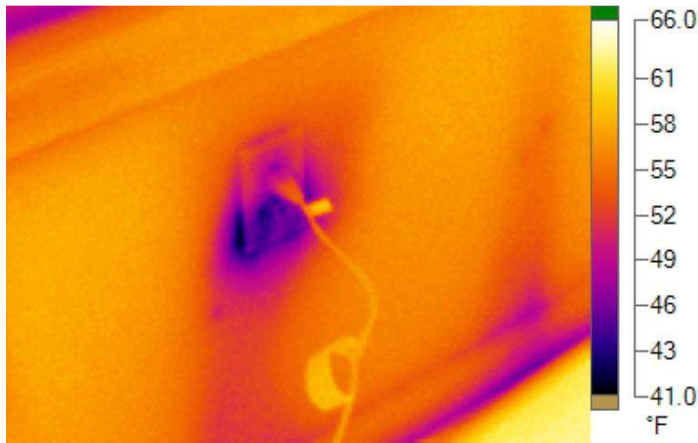
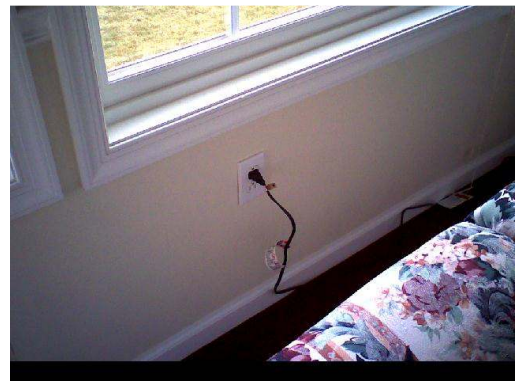
**IR001038.IS2**  
12/18/2009 9:09:48 AM  
Air infiltration at electrical receptacle

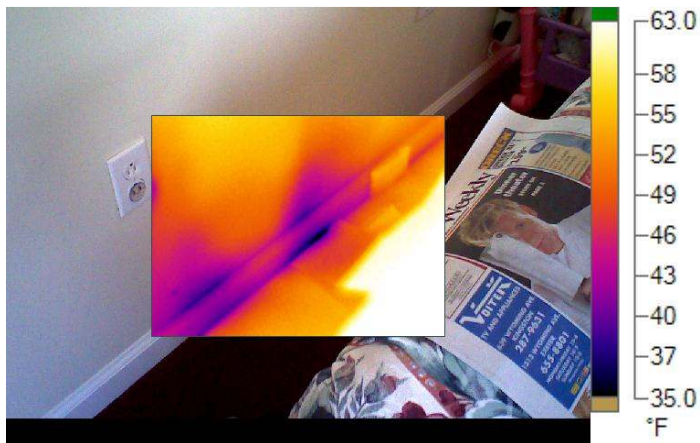
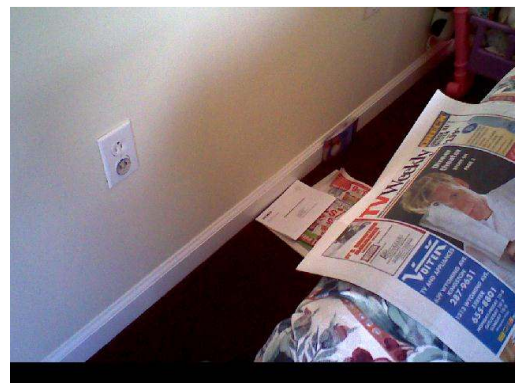
**IR001041.IS2**  
12/18/2009 9:19:40 AM  
Air infiltration along baseboard

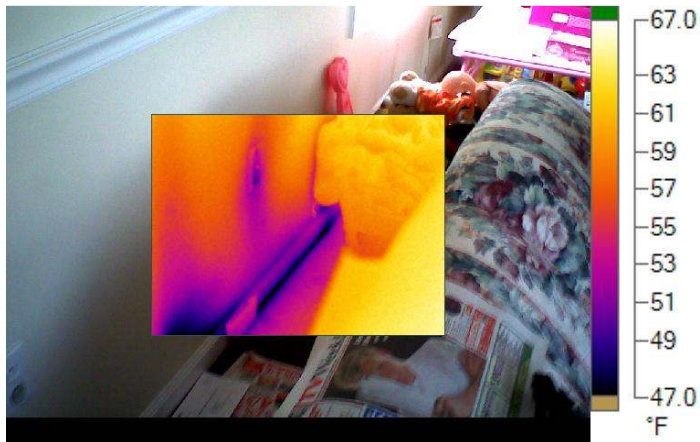
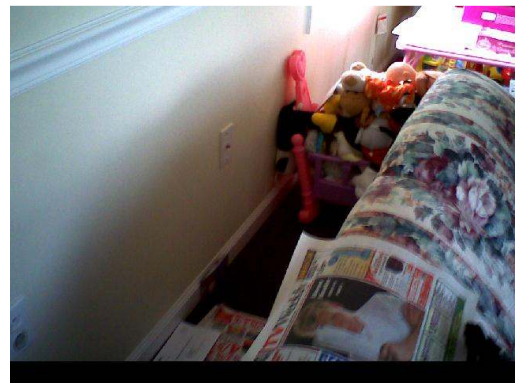
**IR001042.IS2**

Air infiltration along baseboard

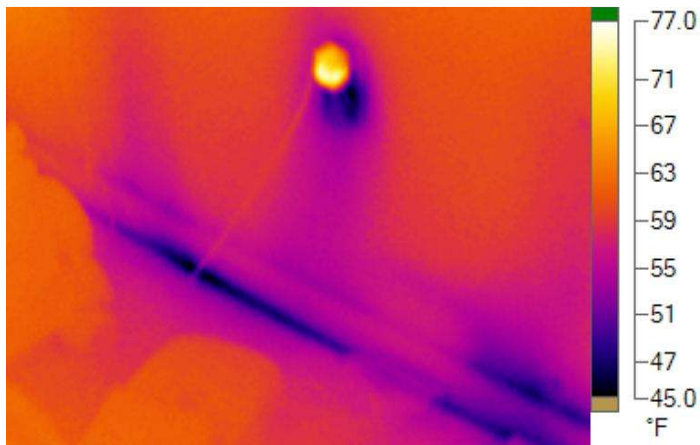
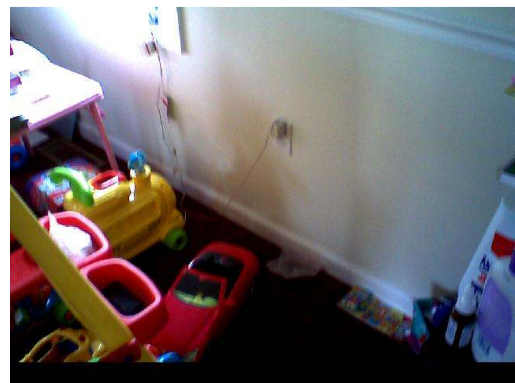
**IR001043.IS2**

Air infiltration at electrical receptacle and along baseboard

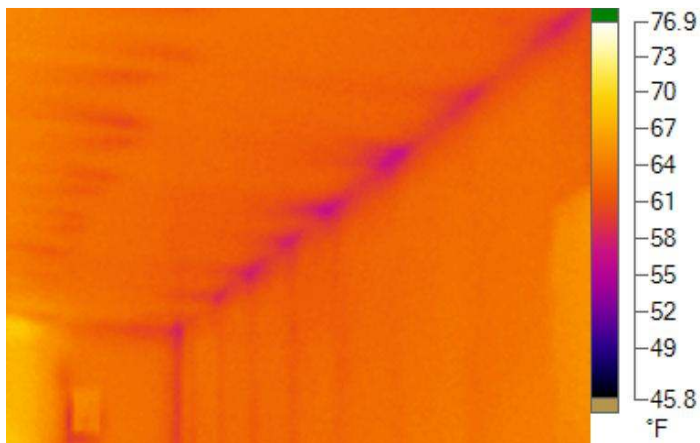
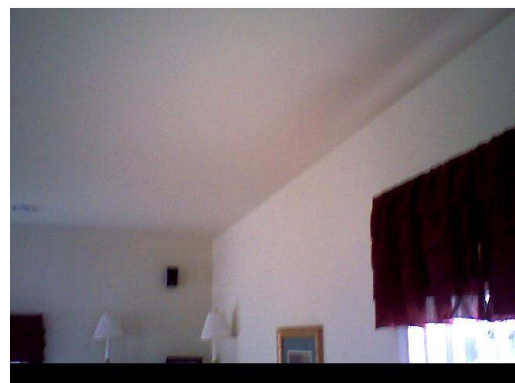
**IR001045.IS2**

Air infiltration at wall

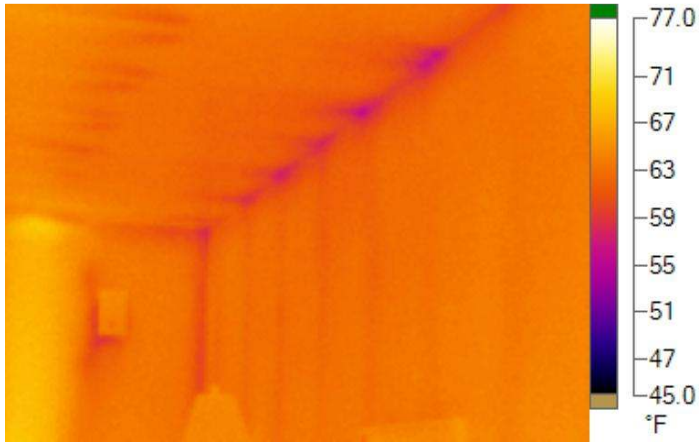
**IR001046.IS2**

Air infiltration at wall

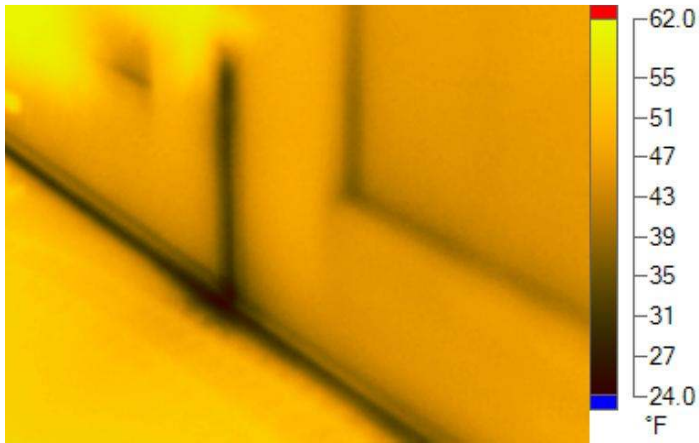
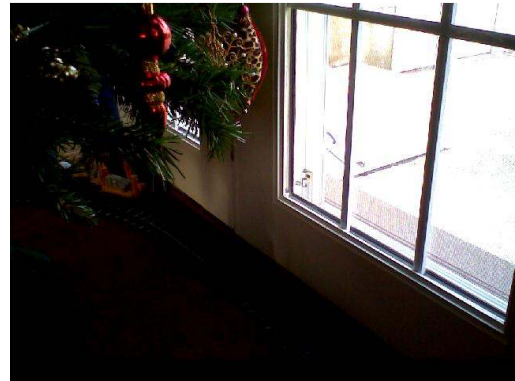
**IR001047.IS2**

Air infiltration at French doors

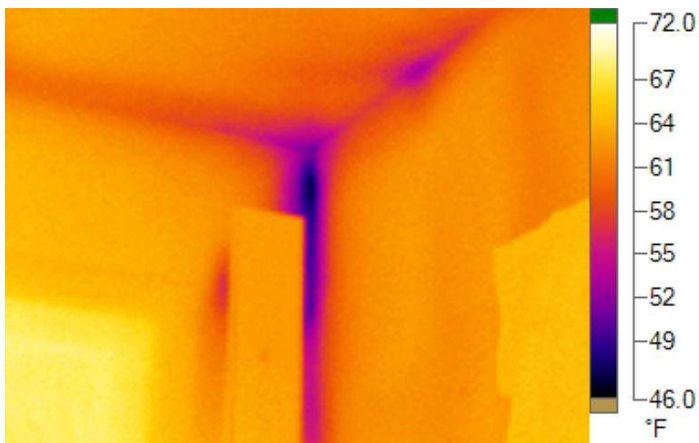
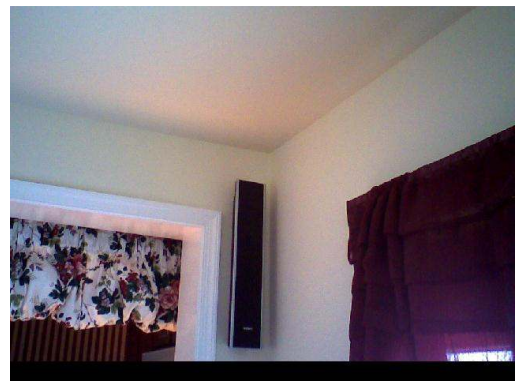
**IR001048.IS2**

Air infiltration at wall

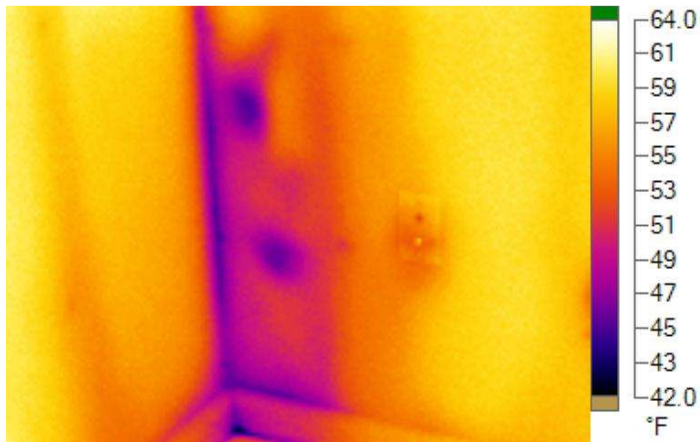
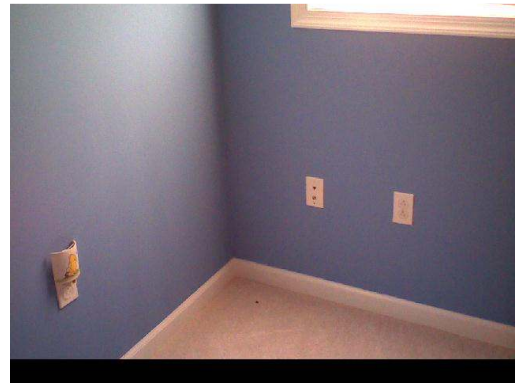
**IR001049.IS2**  
12/18/2009 9:33:39 AM  
Air infiltration at wall

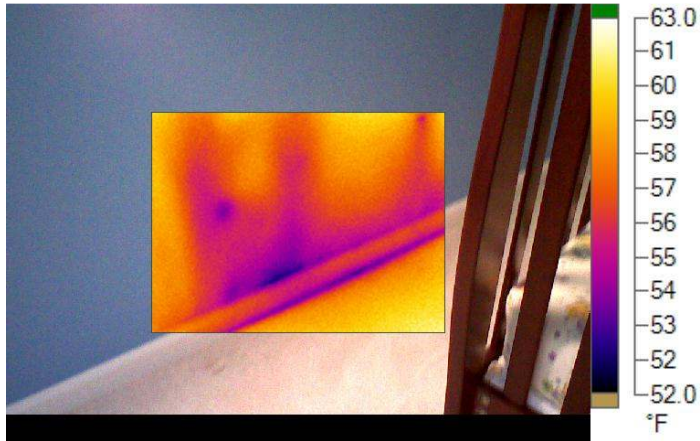
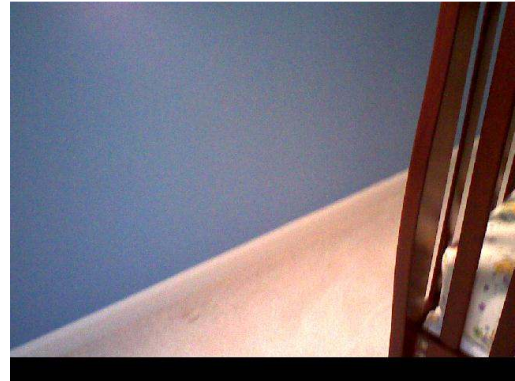
**IR001050.IS2**  
12/18/2009 9:34:52 AM  
Air infiltration at wall

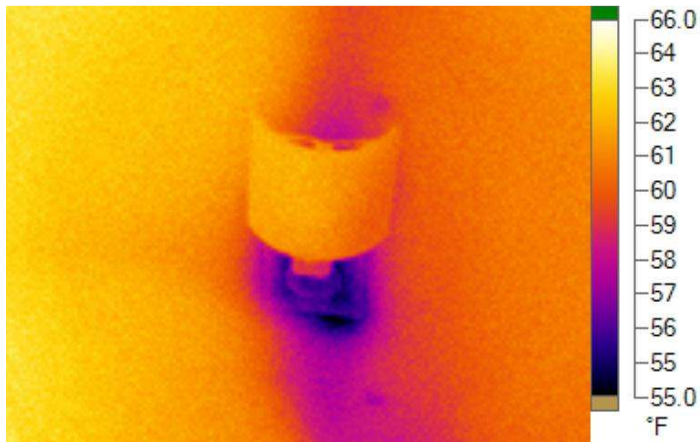
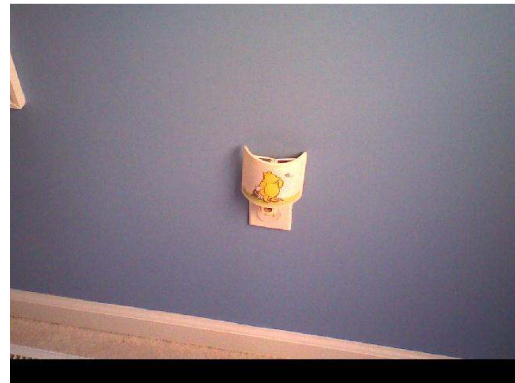
**IR001052.IS2**

Air infiltration at outlet

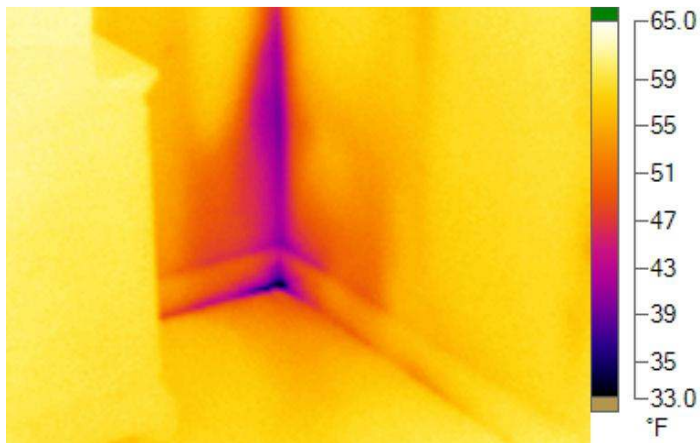
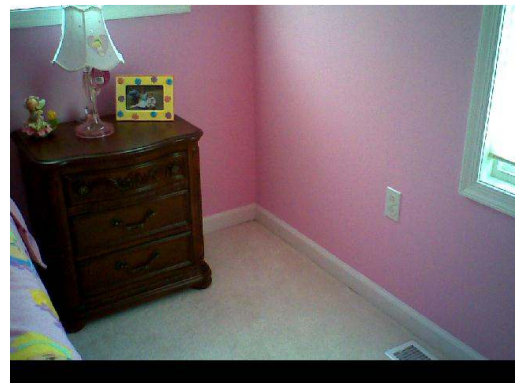
**IR001053.IS2**

Cold plum in corner

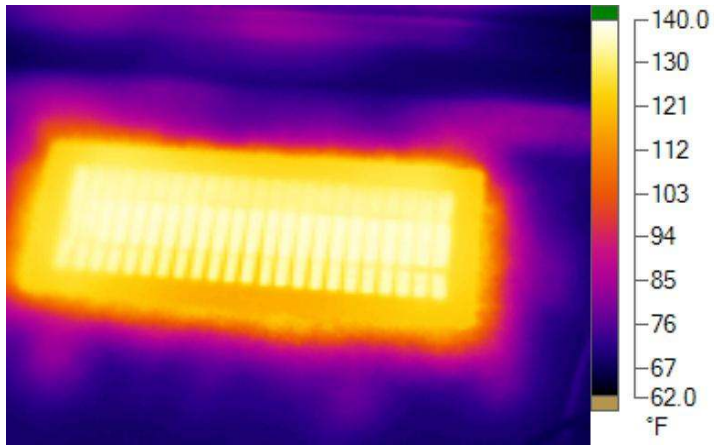
**IR001060.IS2**  
12/18/2009 10:12:20 AM  
Strong flow of hot air to upstairs bedrooms

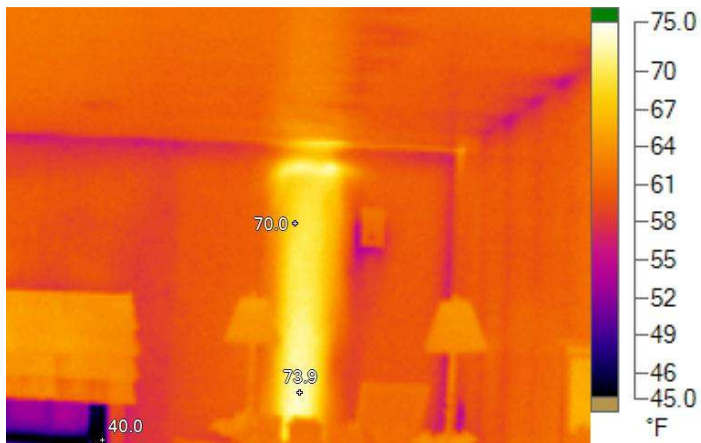
**IR001061.IS2**  
12/18/2009 10:16:45 AM  
Image displays heating duct in wall to bedroom

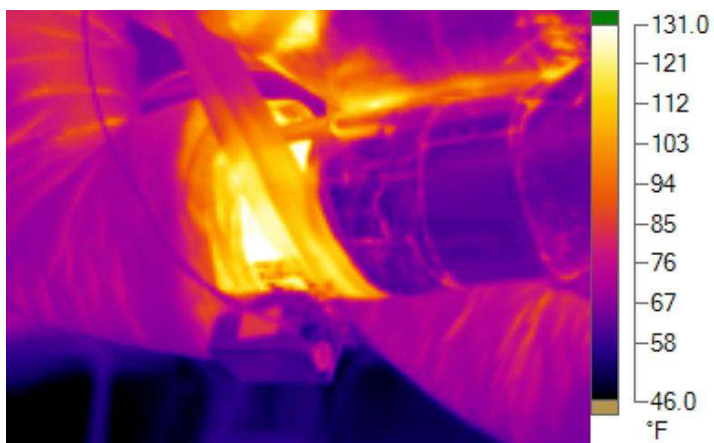
**IR001064.IS2**

No insulation on duct joint can decrease efficiency
