## GCS Home Inspections and Thermal Imaging

# Infrared Thermal Survey

## *Heat Loss Survey*

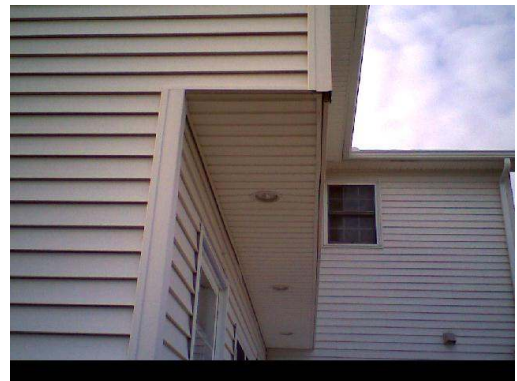
**IR001031.IS2**  
12/18/2009 8:52:48 AM  
Heat loss

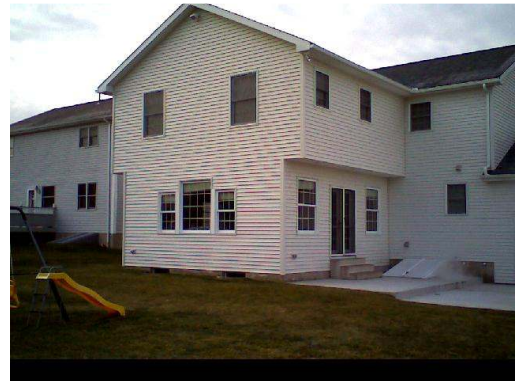
Heat loss at basement exterior wall

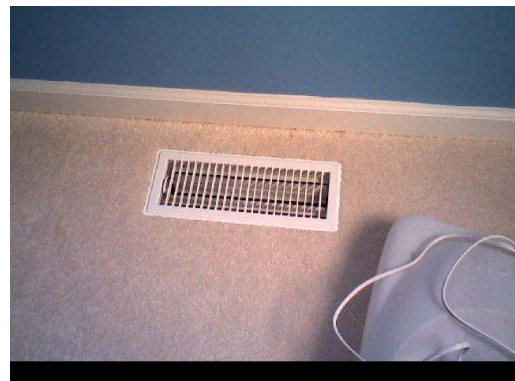
**IR001060.IS2**  
12/18/2009 10:12:20 AM  
Strong flow of hot air to upstairs bedrooms
